**DRAFT REPORT
ROUND 7 DAM ASSESSMENT
ALLETE, INC. - LASKIN ENERGY CENTER
CELLS A-D AND CELL E IMPOUNDMENTS**

November 18, 2010

Re: Round 7 Dam Assessment - Draft Report
EPA Contract No. EP10W001313
Allete Inc. Laskin Energy Center
Cells A-D Impoundment and Cell E Impoundment
Hoyts Lake, Minnesota

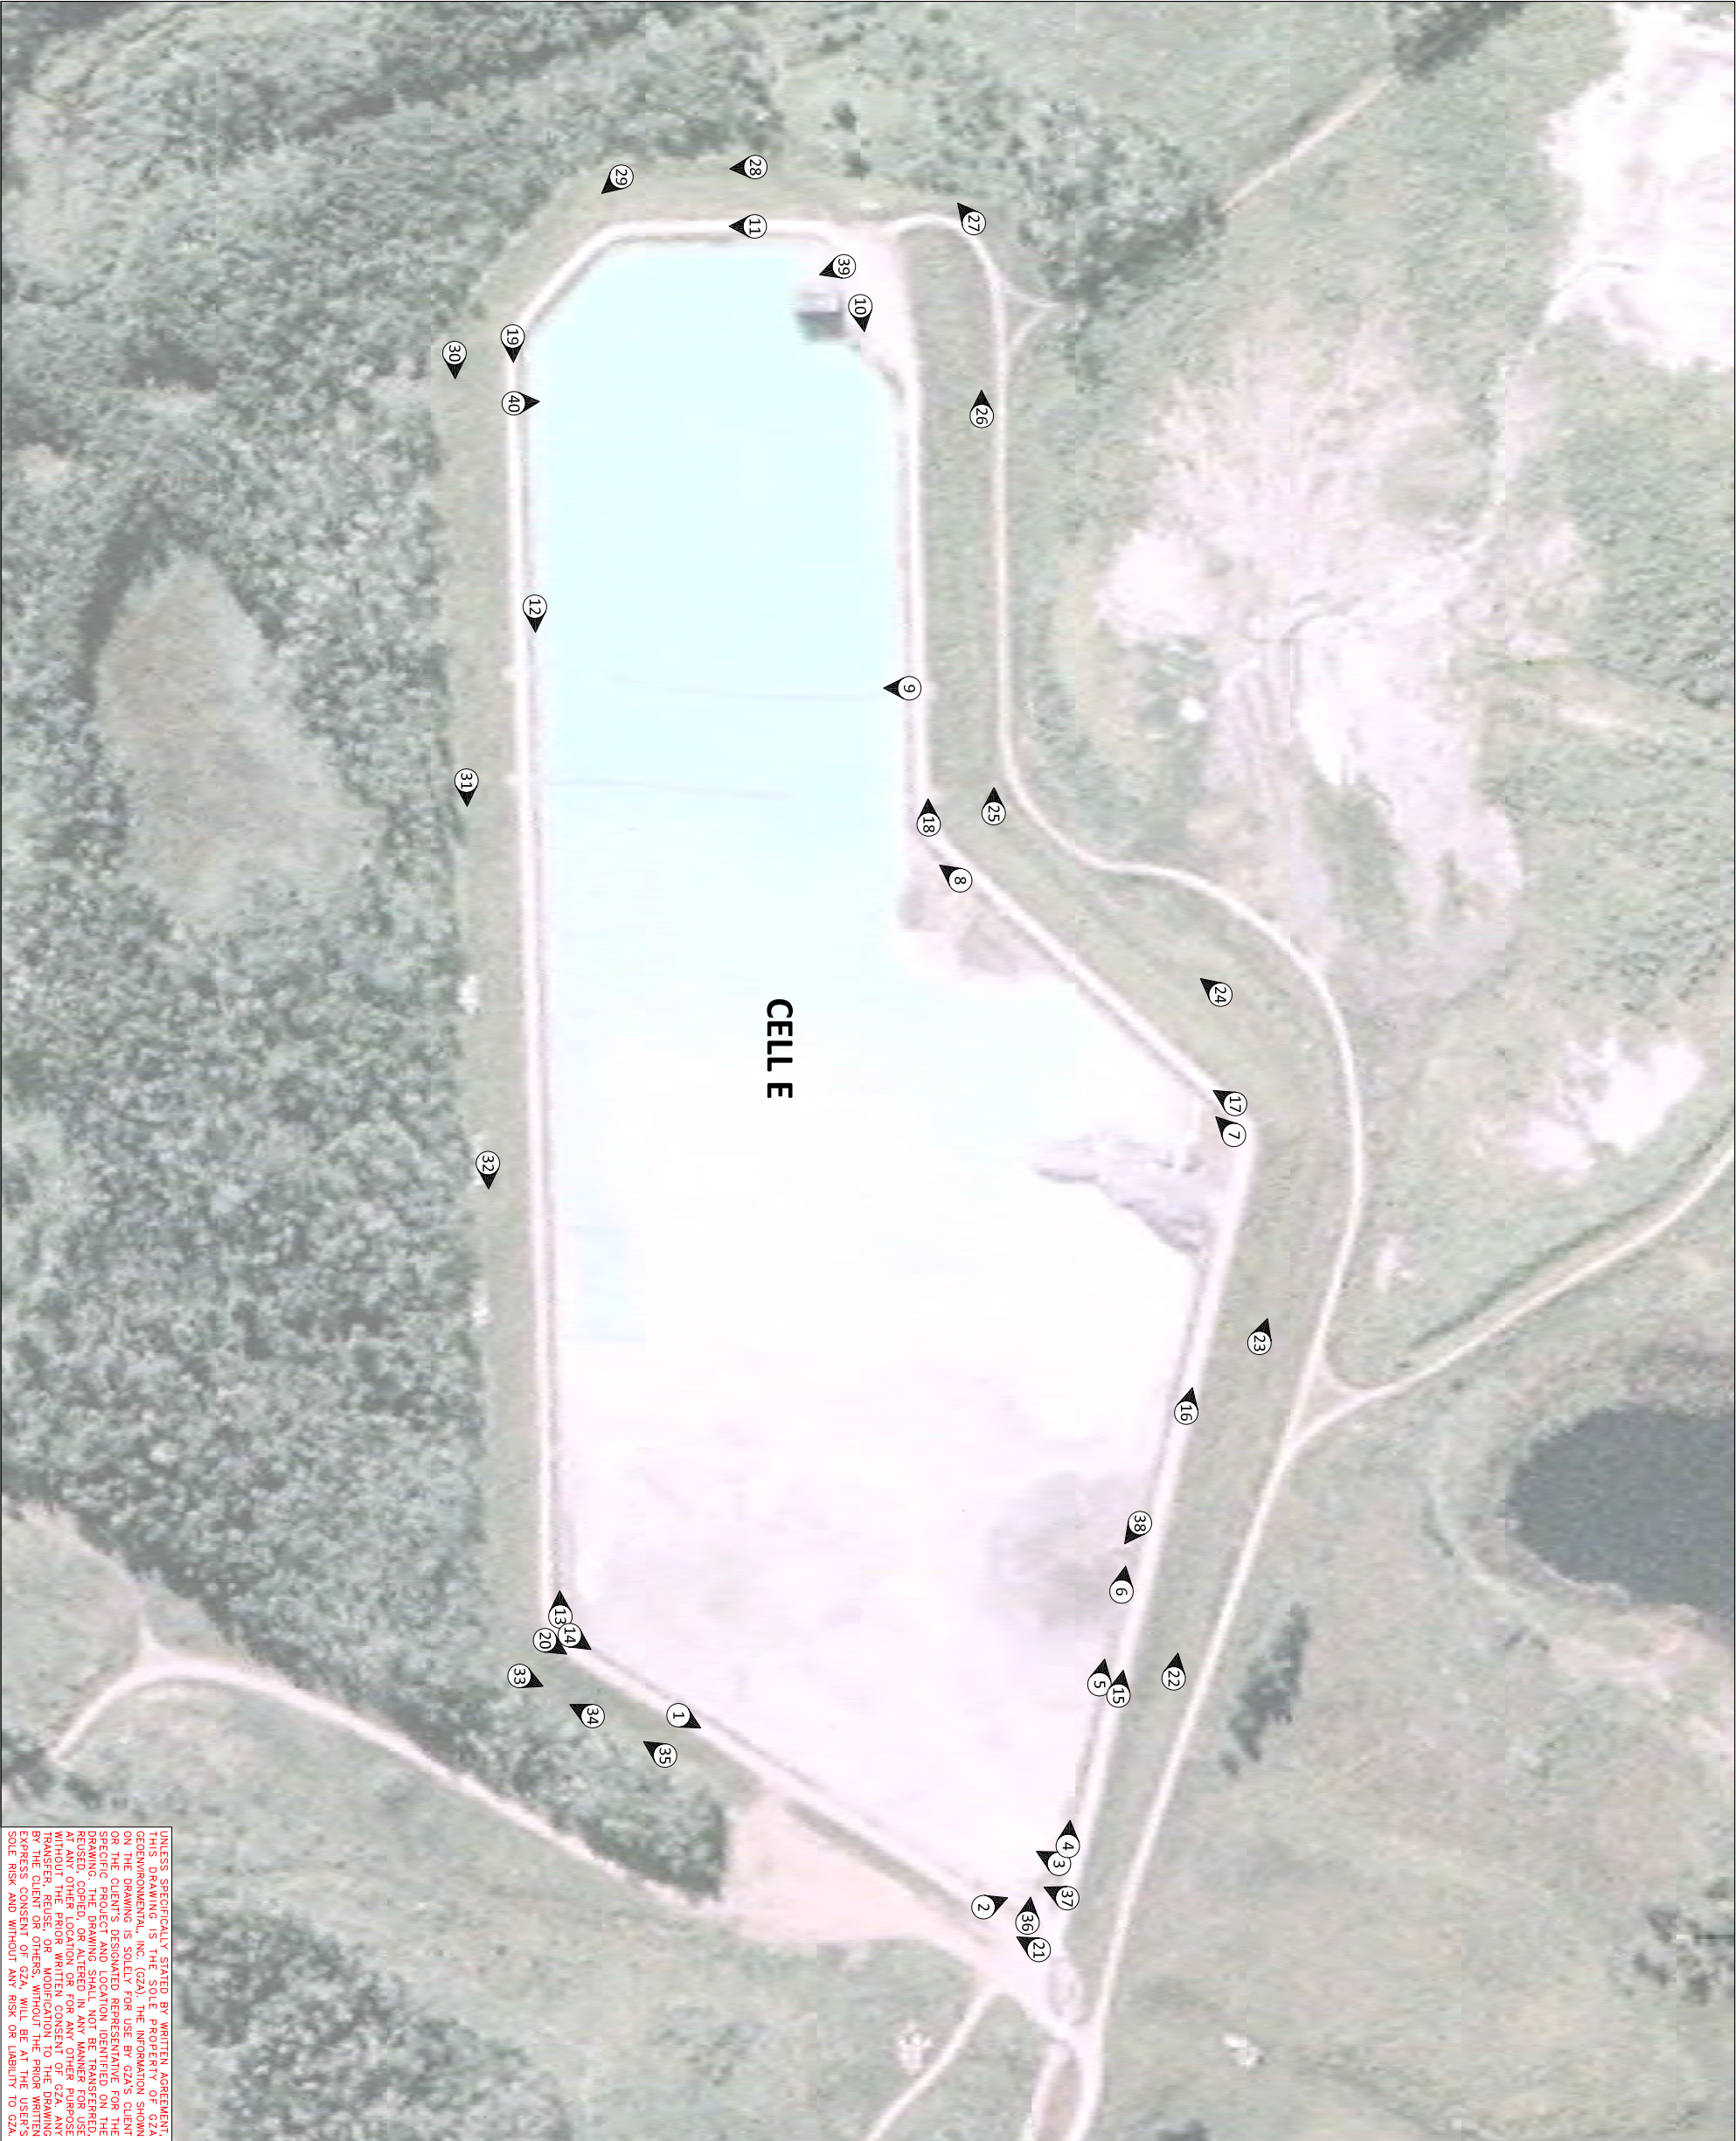
In general, the Cell E Impoundment was found to be in **SATISFACTORY** condition. The specific concerns are identified in more detail in the sections below. An overall site plan showing the impoundments is provided as **Figure 2**. A site plan showing key features of the Cell E impoundment, including deficiencies observed during the current inspection, is provided as **Figure 4**. The location and orientation of photographs provided in **Appendix E** is shown on the Photo Plan in **Figure 5**.

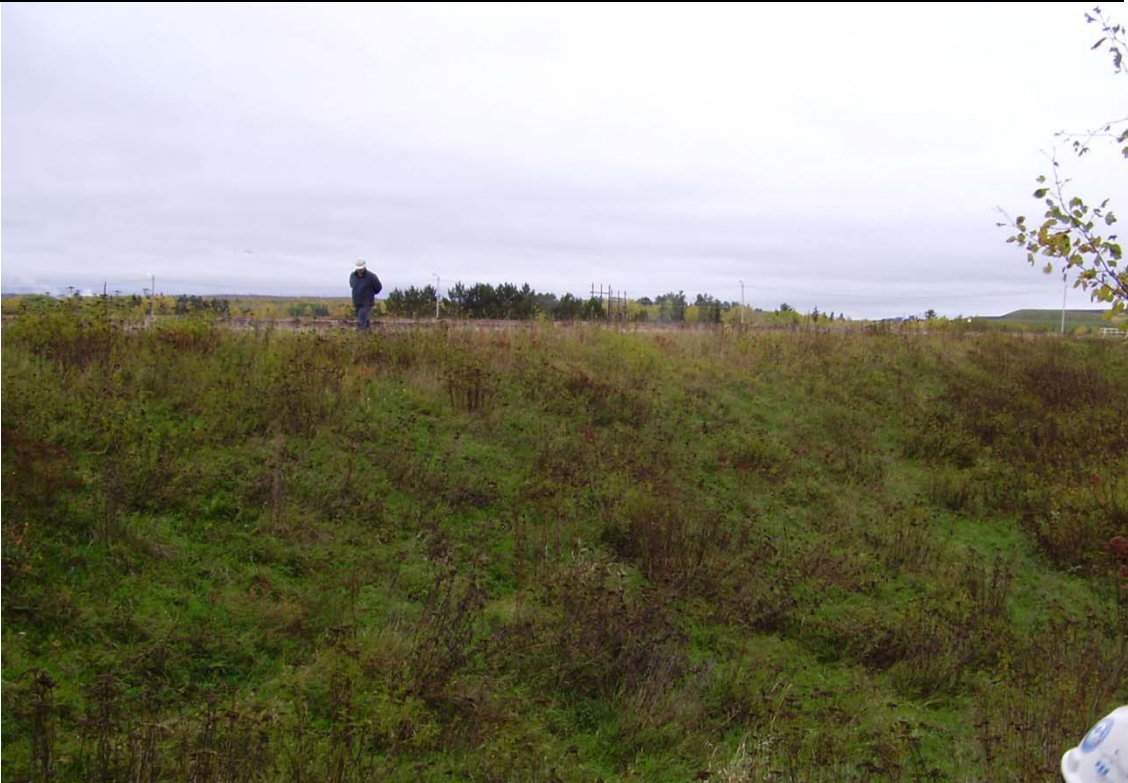
Client Name: U.S. EPA		Site Location: Laskin Energy Center Hoyt Lakes, MN	Project No. 01.0170142.20
Photo No. 33	Date: 9/23/10

Direction Photo Taken: Northwest			
Description: Downstream slope and toe of Cell E.
